Re: Meridian Automotive Systems Site  
Jackson, Jackson County, Ohio  
Technical Direction Document No.: S05-0001-1001-001  
Work Order No.: 20405.012.001.0902.00  
Document Control No.: 902-2A-AHFN

This letter report discusses the Site description, Site background, waste removal activities, disposal activities, and resources committed to the removal action. In addition, this letter report includes six attachments. Attachment A provides the figures for this letter report, Attachment B provides photographic documentation of Site conditions and removal activities, Attachment C summarizes the analytical results from the ERRS-procured laboratory, Attachment D summarizes the results of HAZCAT analysis, and Attachment E provides copies of the waste manifests.

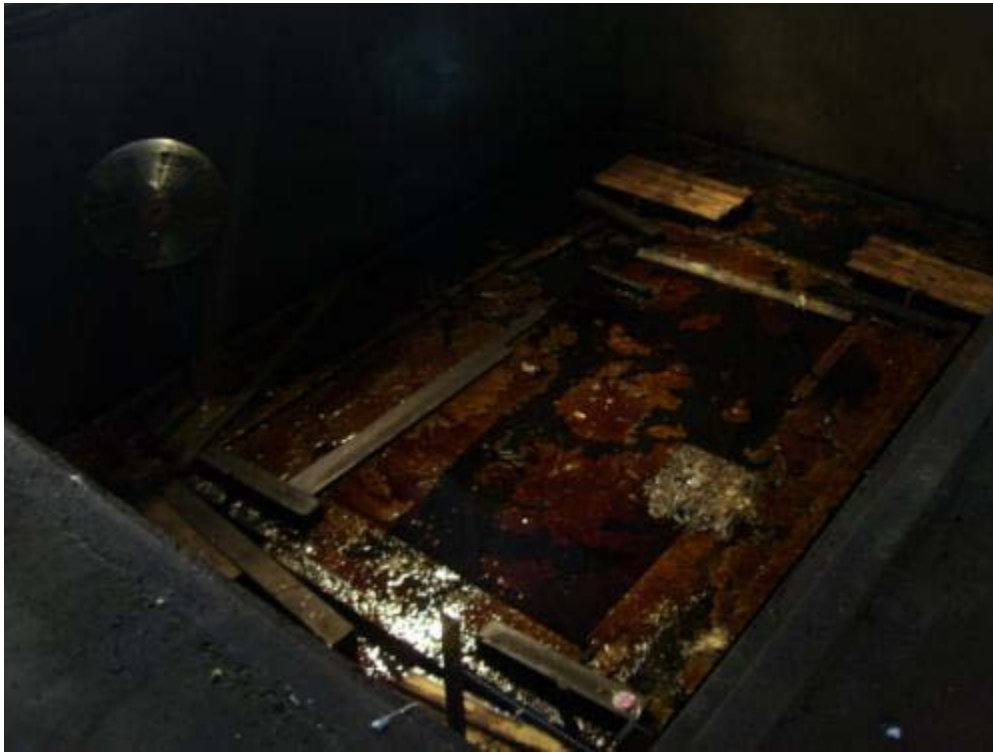
**Photograph No.:** 1

**Subject:** Waste hydraulic oil and debris in subfloor pit P001 in Room 1

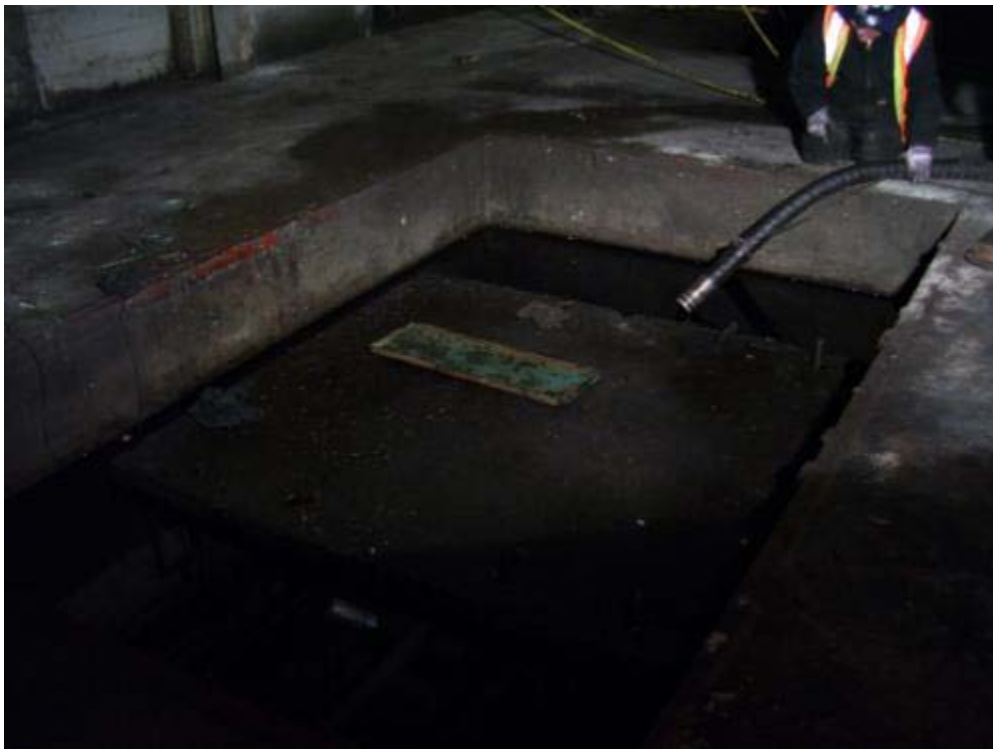
**Photograph No.:** 2

**Subject:** Removal of mixed oil and water waste from subfloor pit P007 in Room 17

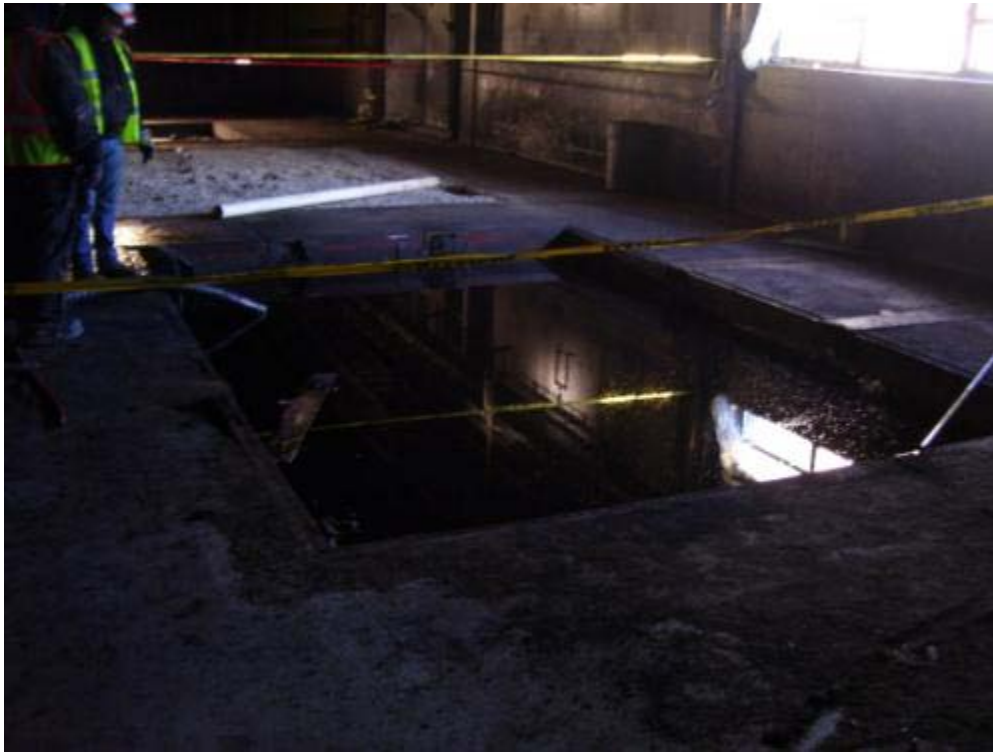
**Photograph No.:** 3

**Subject:** Removal of hydraulic oil waste from subfloor pit P015 in Room 17

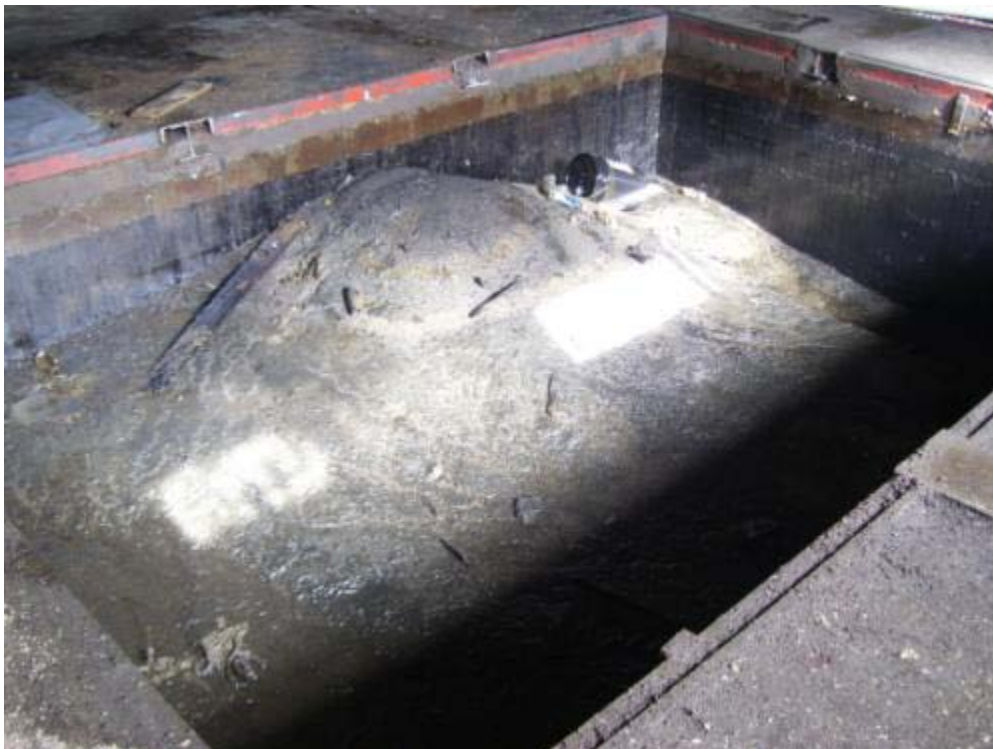
**Photograph No.:** 4

**Subject:** Solid waste and sludge in subfloor pit P015 after the removal of liquid waste

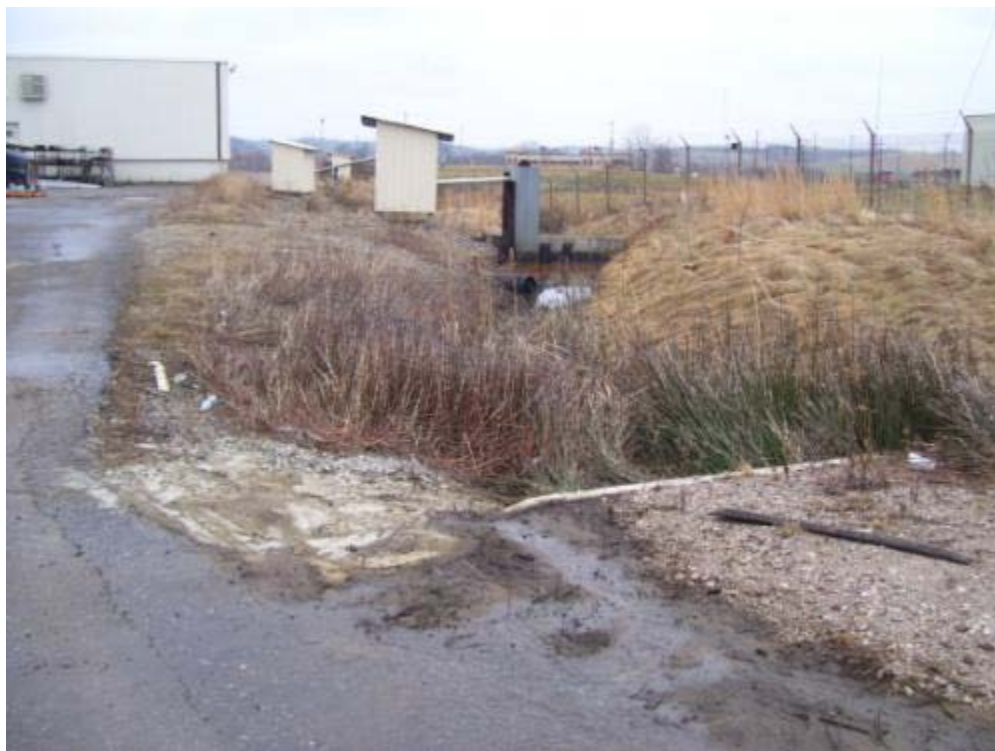
**Photograph No.:** 8

**Subject:** View of the storm water treatment ditch with underflow dams and oil skimmers

A layer of light oil was observed in the two westernmost portions of the storm water treatment ditch during the removal site assessment. Oil staining was also observed on soil on the banks of the ditch and on vegetation up to approximately 100 feet east of the westernmost underflow dam. Photos of the visual extent of contamination are included in Attachment B.

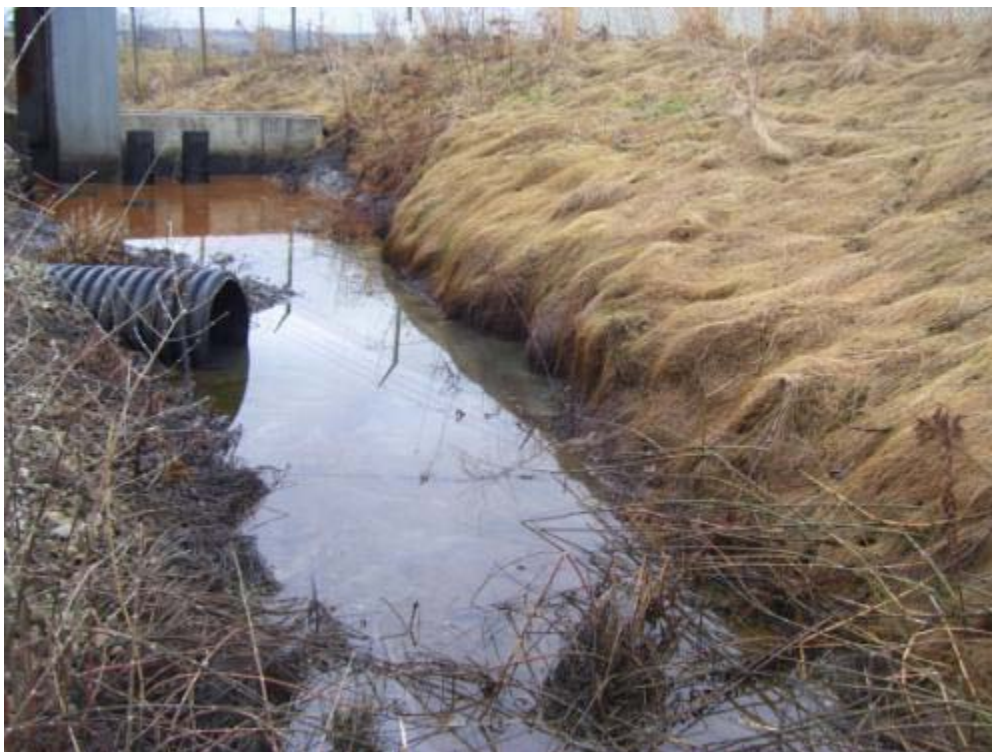
**Photograph No.:** 9

**Subject:** Oil product and oil-stained soil in the storm water treatment ditch

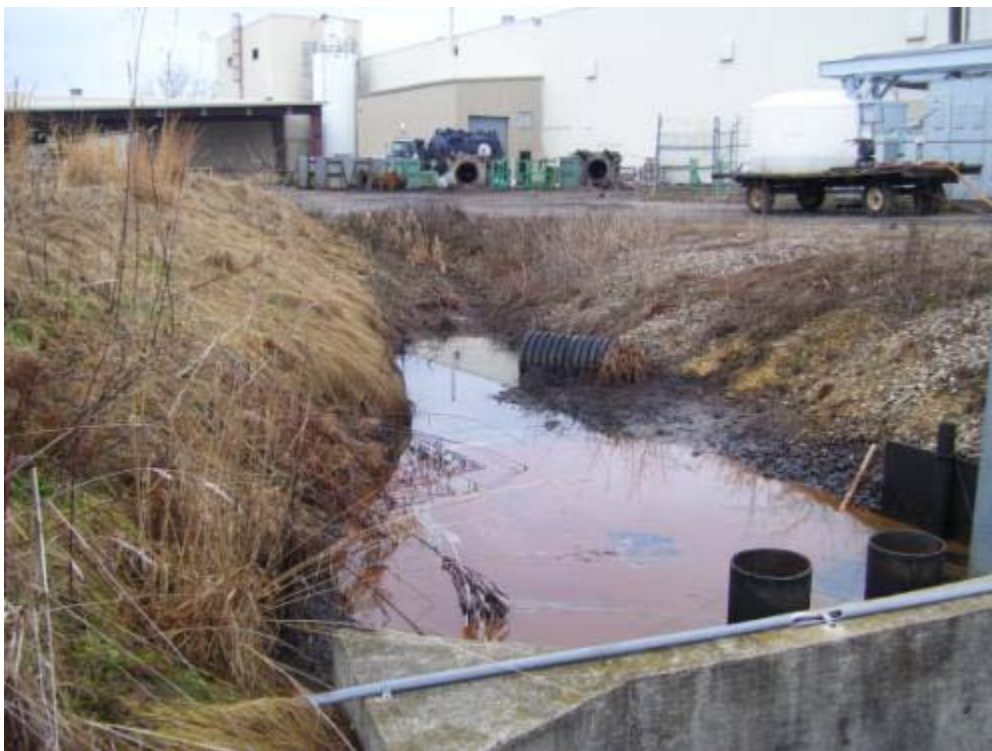
**Photograph No.:** 10

**Subject:** Oil product and oil-stained soil in the storm water treatment ditch

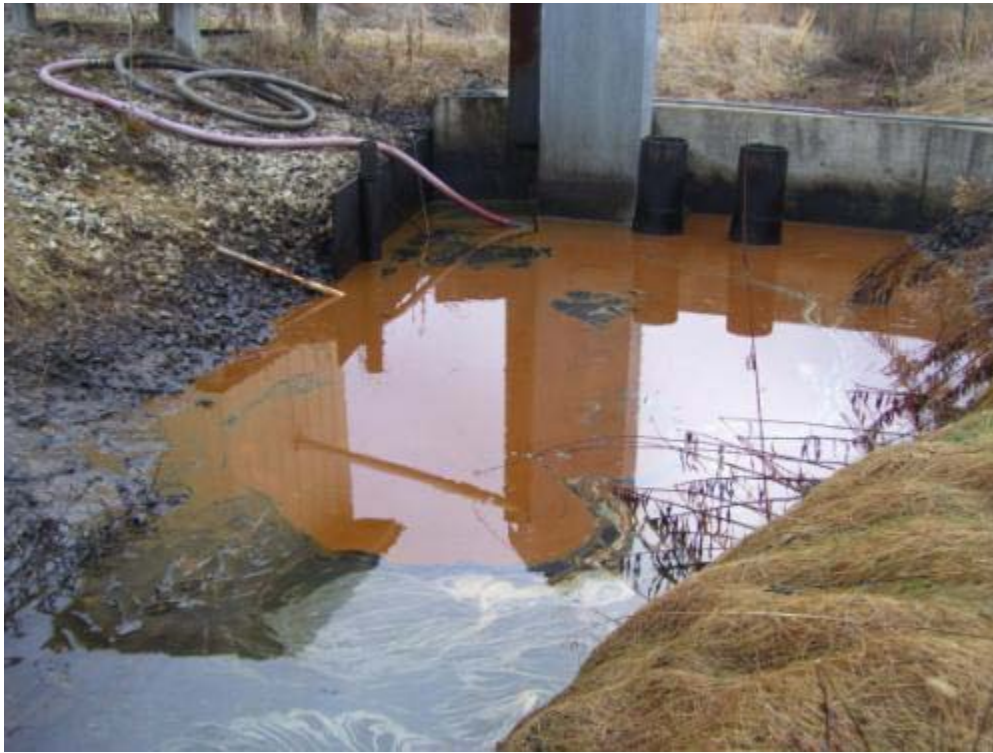
**Photograph No.:** 11

**Subject:** Oil product and oil-stained soil in the storm water treatment ditch

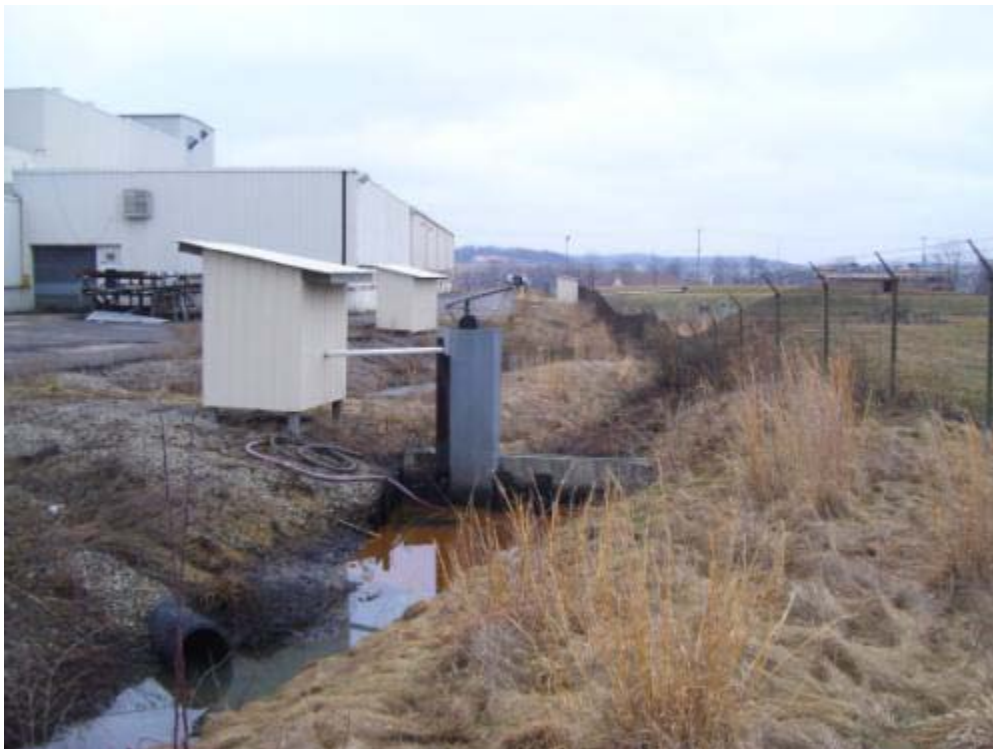
**Photograph No.:** 12

**Subject:** Oil product and oil-stained soil in the storm water treatment ditch

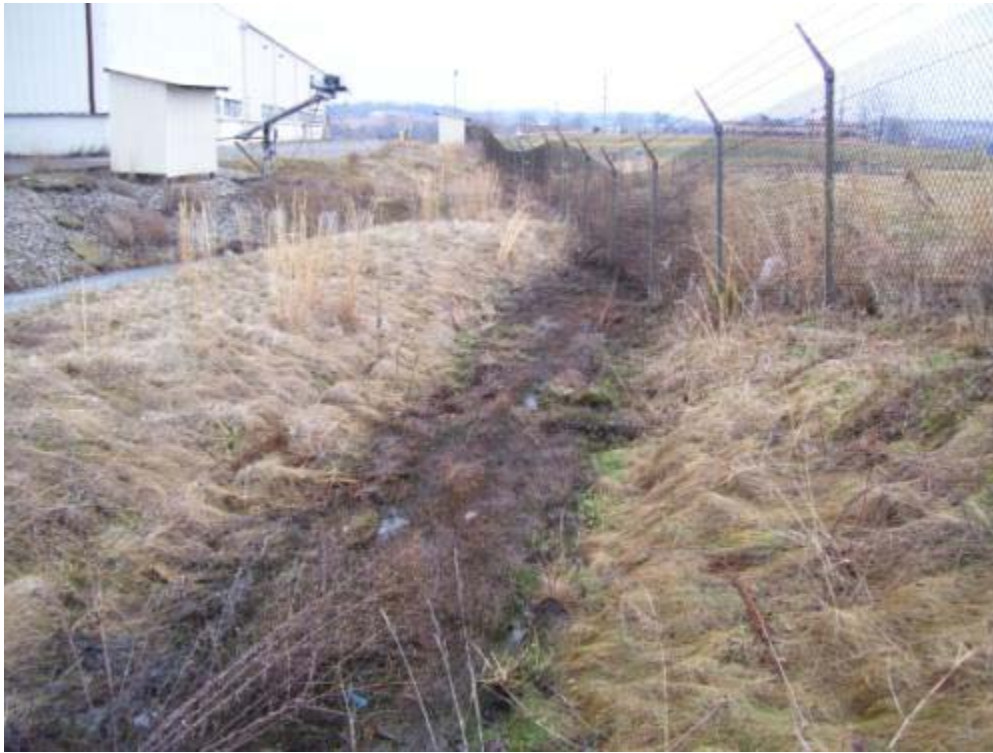
**Photograph No.:** 13

**Subject:** Oil product and oil-stained soil and vegetation in the storm water treatment ditch

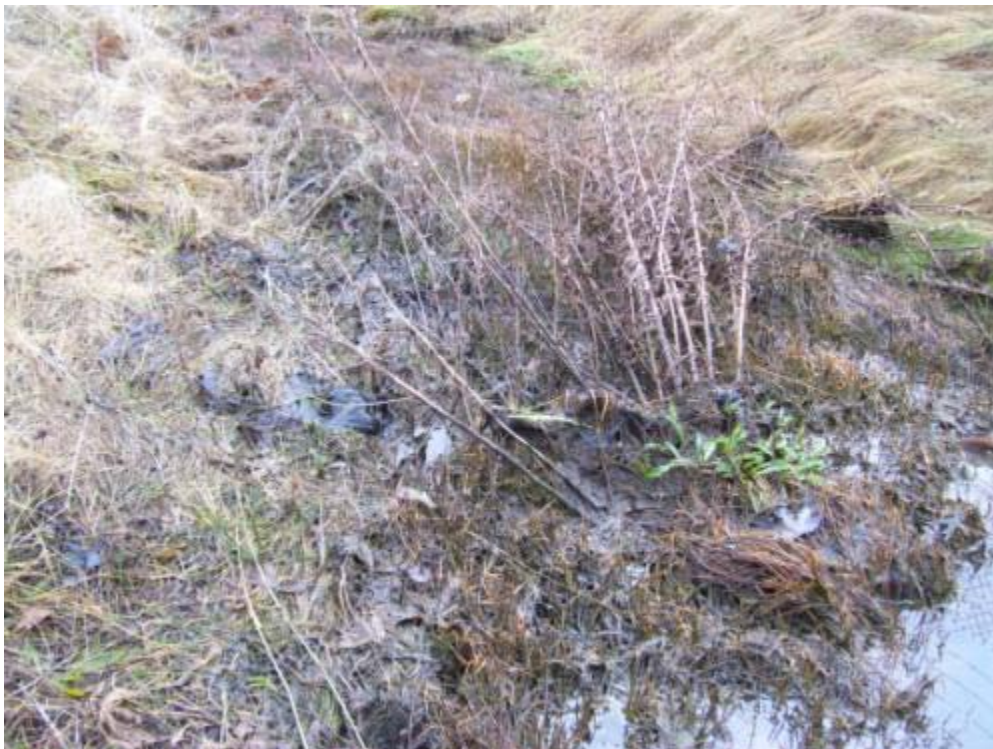
**Photograph No.:** 14

**Subject:** Oil product and oil-stained soil and vegetation in the storm water treatment ditch

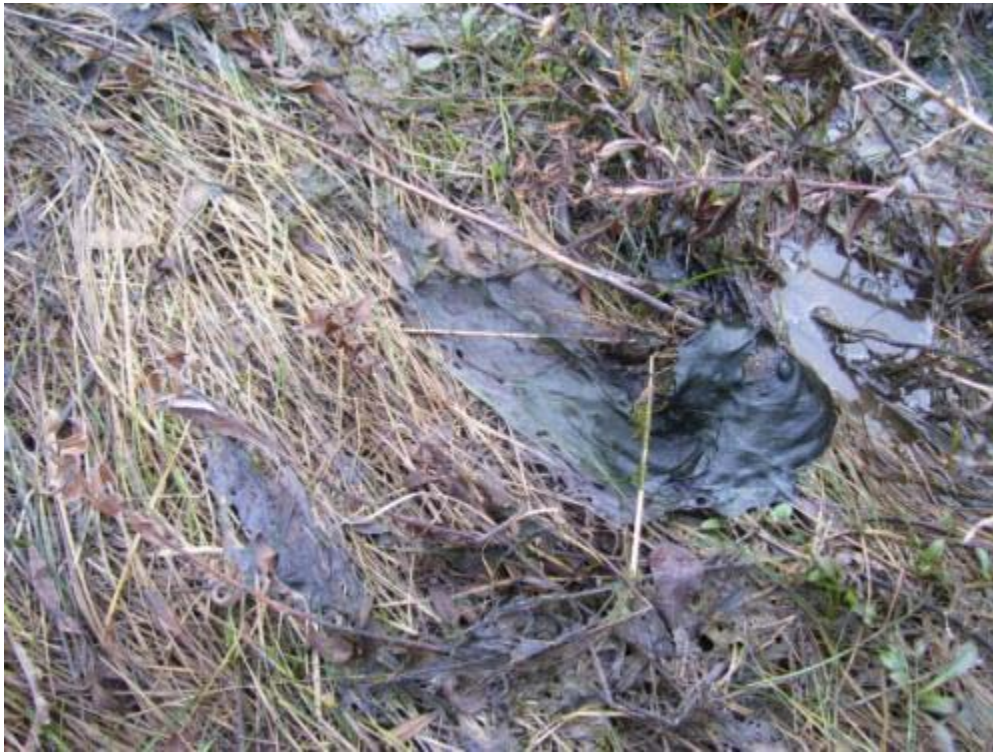
**Photograph No.:** 15

**Subject:** Oil product and oil-stained soil and vegetation in the storm water treatment ditch

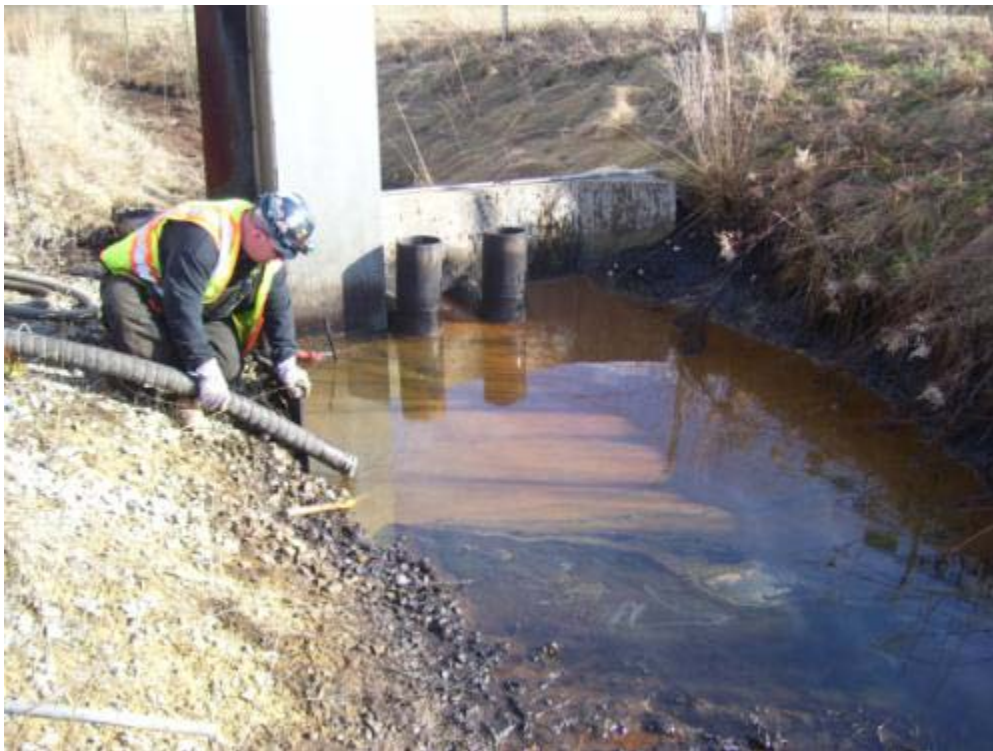
**Photograph No.:** 16

**Subject:** Removal of mixed oil and water from the storm water treatment ditch

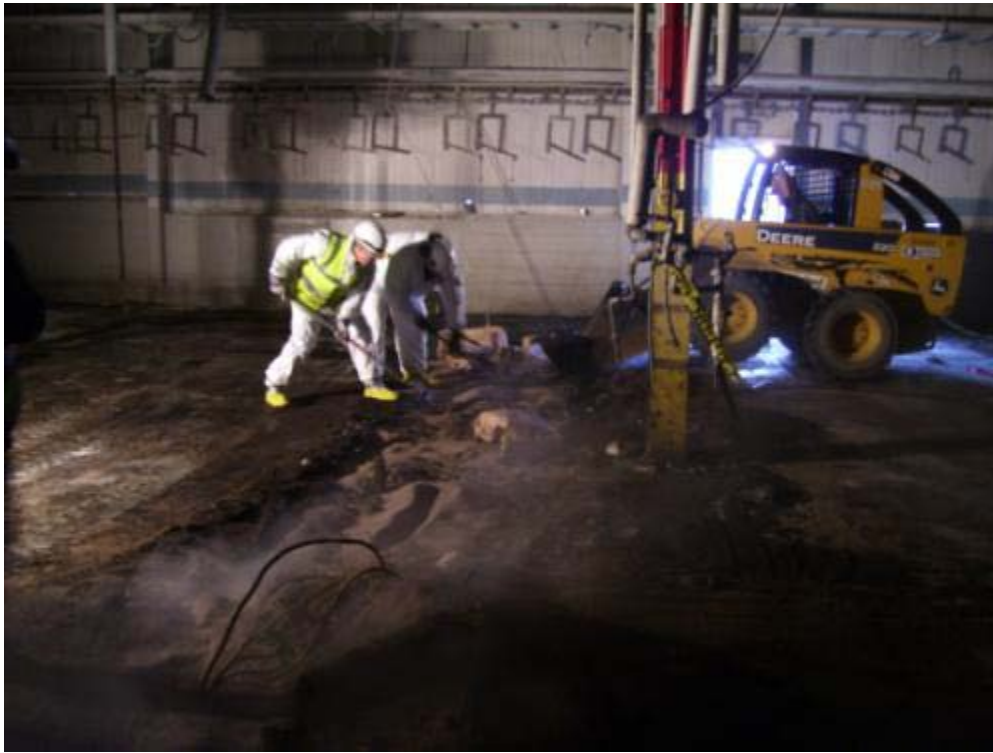
**Photograph No.:** 19

**Subject:** Removal of oil-contaminated liquids and solids from P013 with granular absorbent

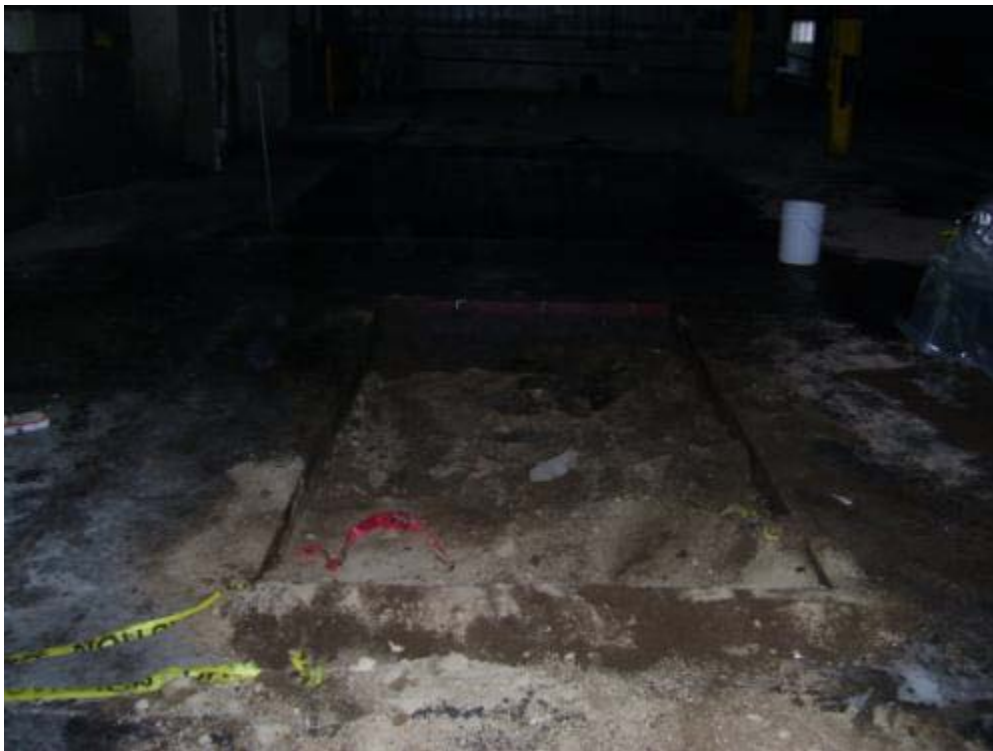
**Photograph No.:** 20

**Subject:** Oil-contaminated solids and granular absorbent in subfloor pit P014

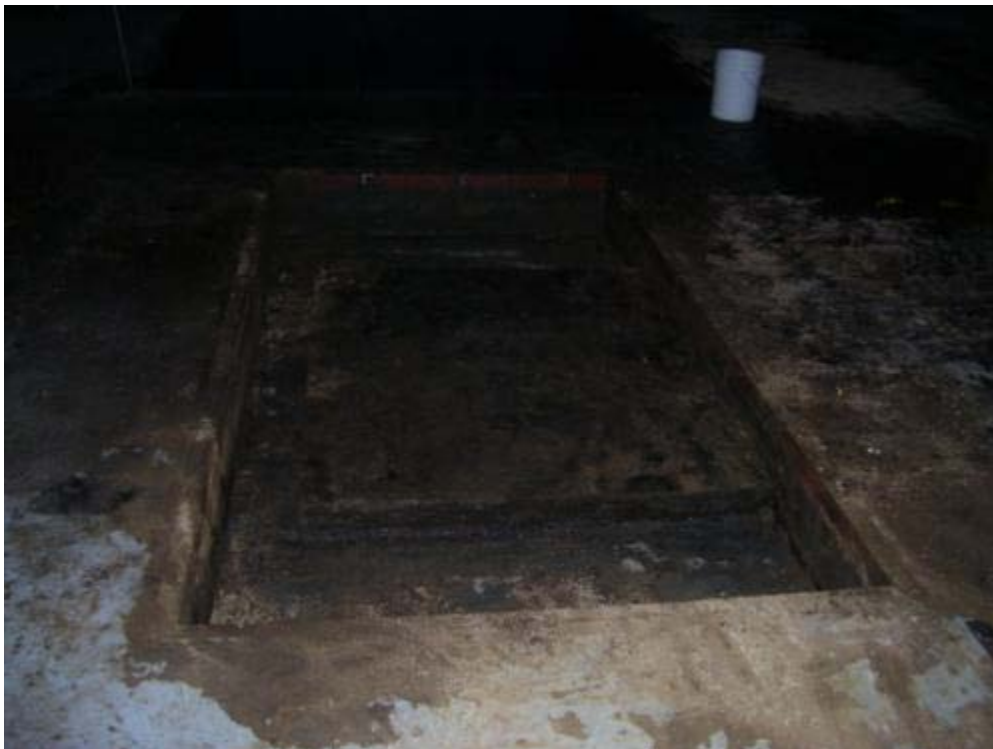
**Photograph No.:** 22

**Subject:** Subfloor pit P014 after the removal of solids

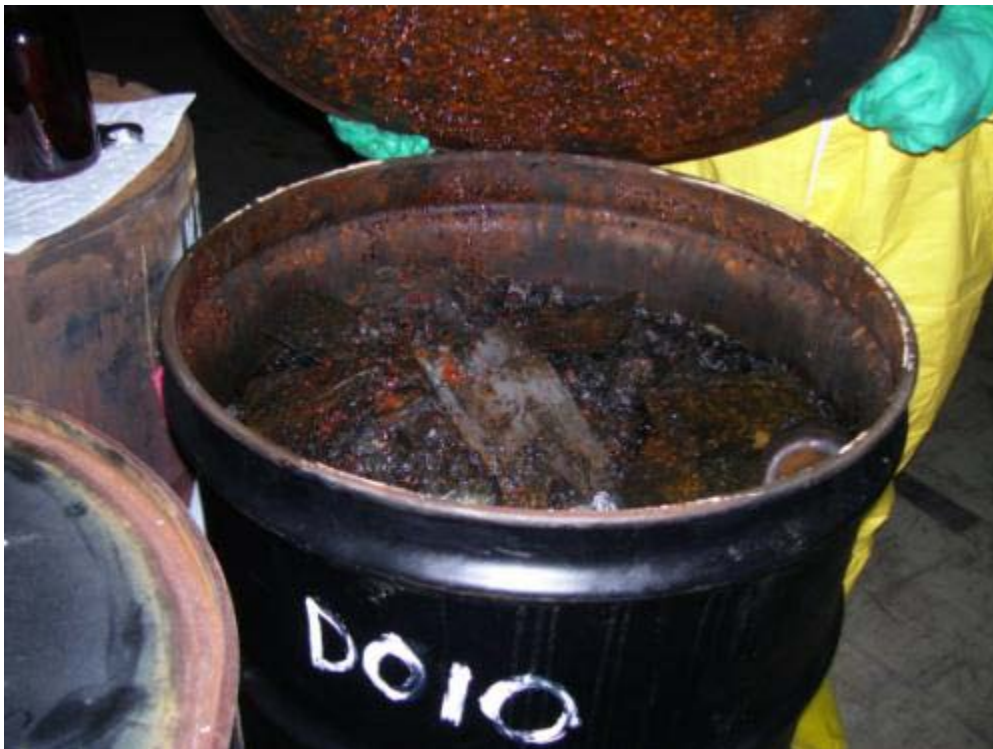
**Photograph No.:** 26

**Subject:** Oil-contaminated solids in drum D010

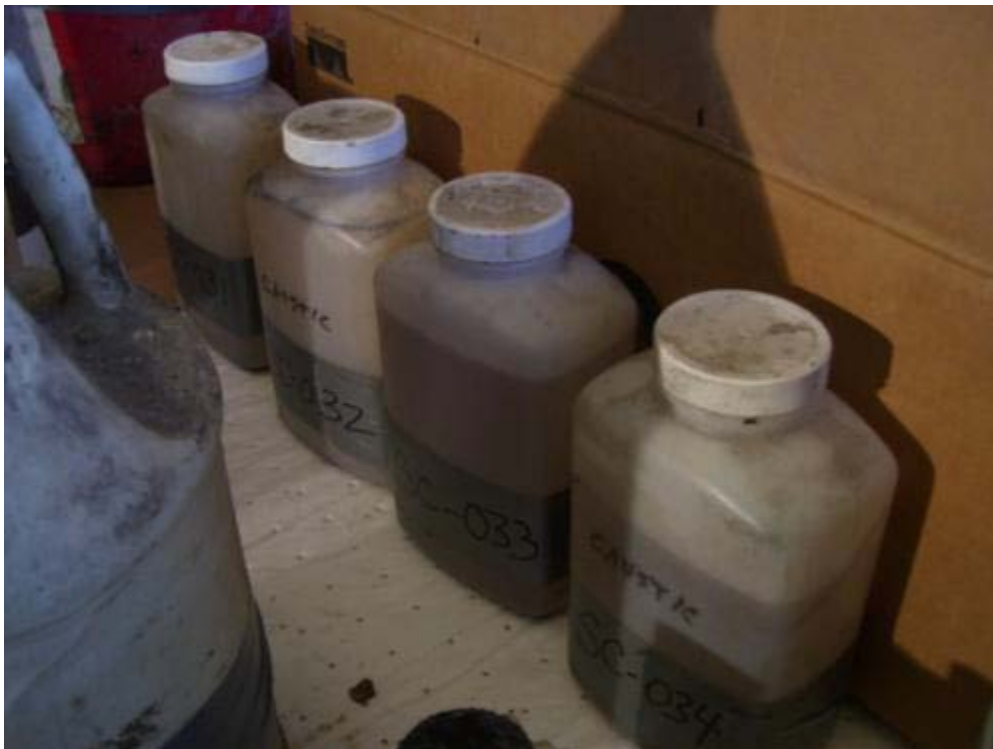
**Photograph No.:** 34

**Subject:** 500-milliliter polyethylene containers SC031–SC034 with caustic markings

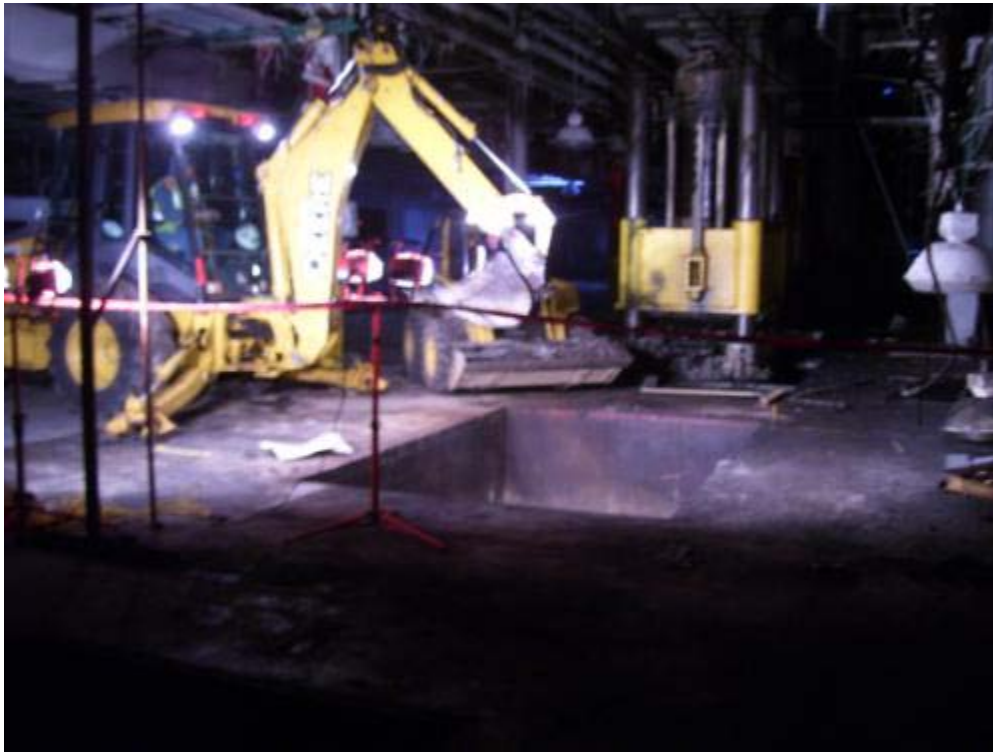
**Photograph No.:** 35

**Subject:** Removal of oil-contaminated solids from subfloor pit P006 with the backhoe

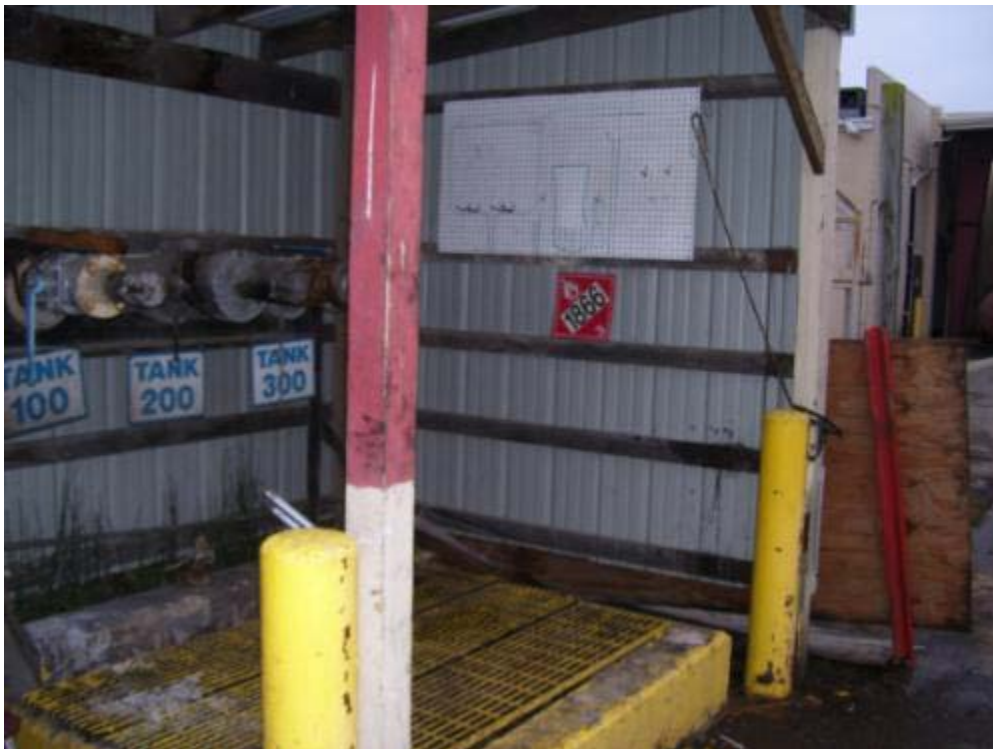
**Photograph No.:** 36

**Subject:** Flammable resin placard at the inlets to tanks T030 (300), T031 (200), and T032 (100)

The former outdoor resin storage tanks T030, T031, T032, and the former resin transfer lines terminating in the SMC mix room (Room 18) contained ignitable waste resins. A Department of Transportation (DOT) placard for flammable resin (UN 1866) was found at the nearby loading station for tanks T030 through T032. The ERRS crew gained access to the contents of the resin tanks through bolted side-hatches. ERRS was directed to remove as much residual liquid resin as possible through pumping or manual removal methods.

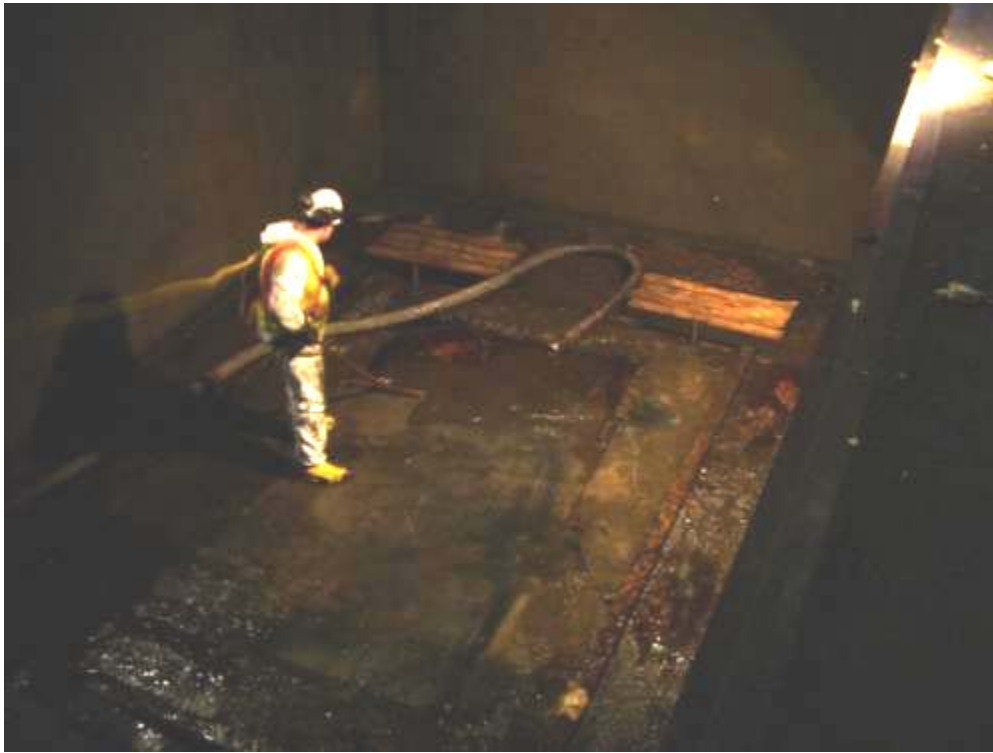
**Photograph No.:** 37

**Subject:** Removal of residual liquid from subfloor pit P001 with the vacuum truck

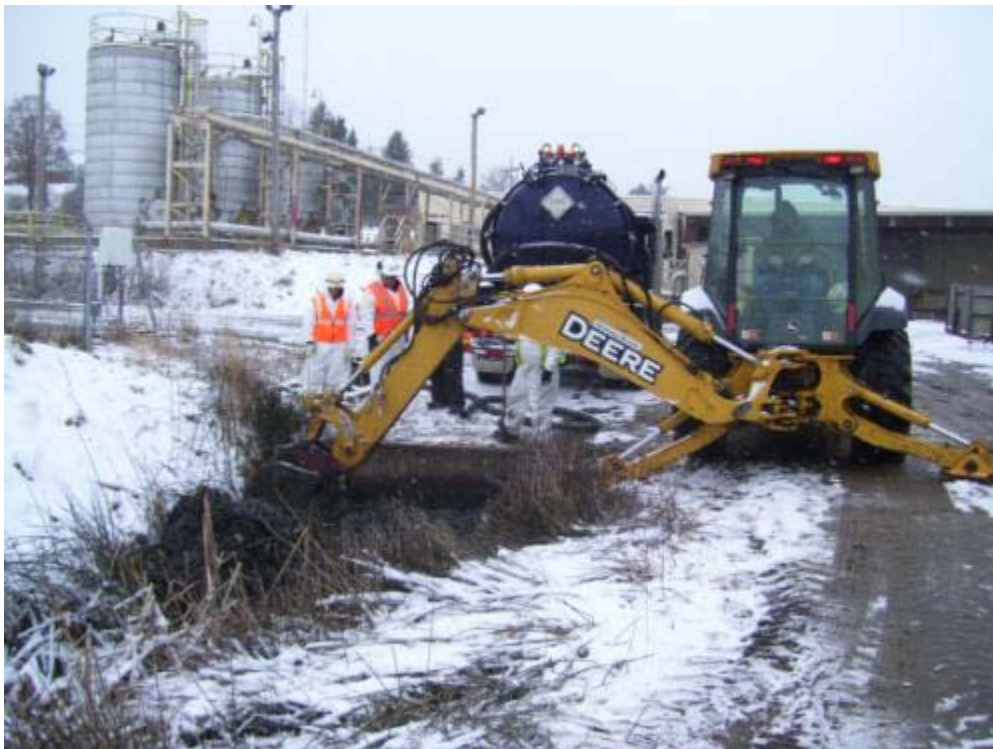
**Photograph No.:** 38

**Subject:** Removal of oil-contaminated sediment and soil from the storm water treatment ditch

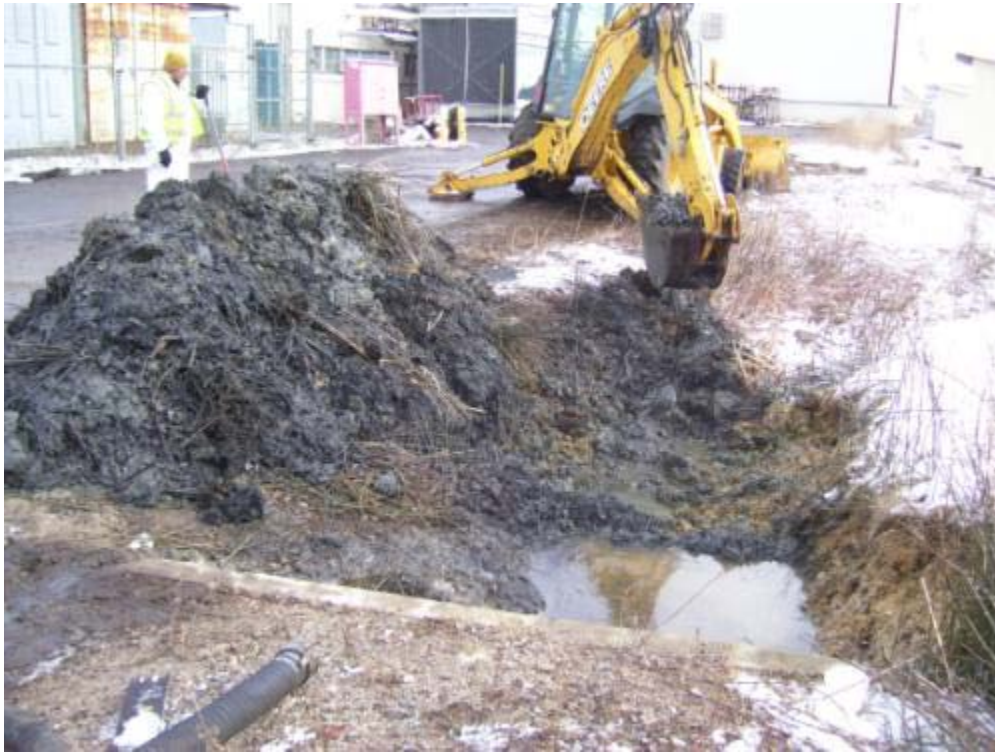
**Photograph No.:** 39

**Subject:** Removal of oil-contaminated sediment and soil from the storm water treatment ditch

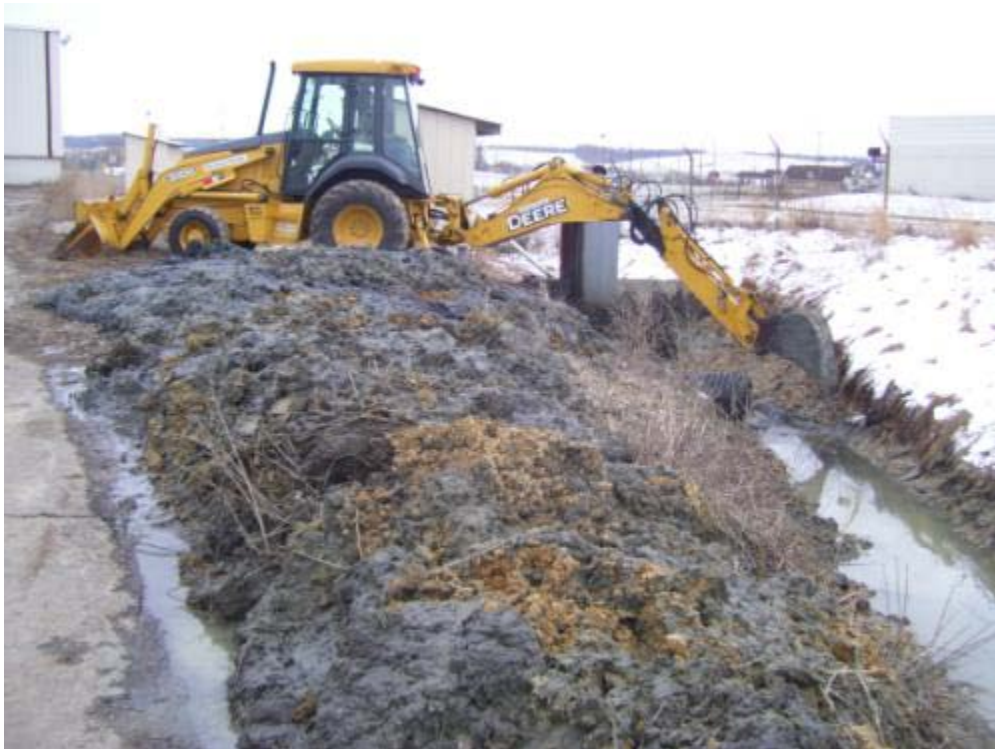
**Photograph No.:** 40

**Subject:** Removal of oil-contaminated sediment and soil from the storm water treatment ditch

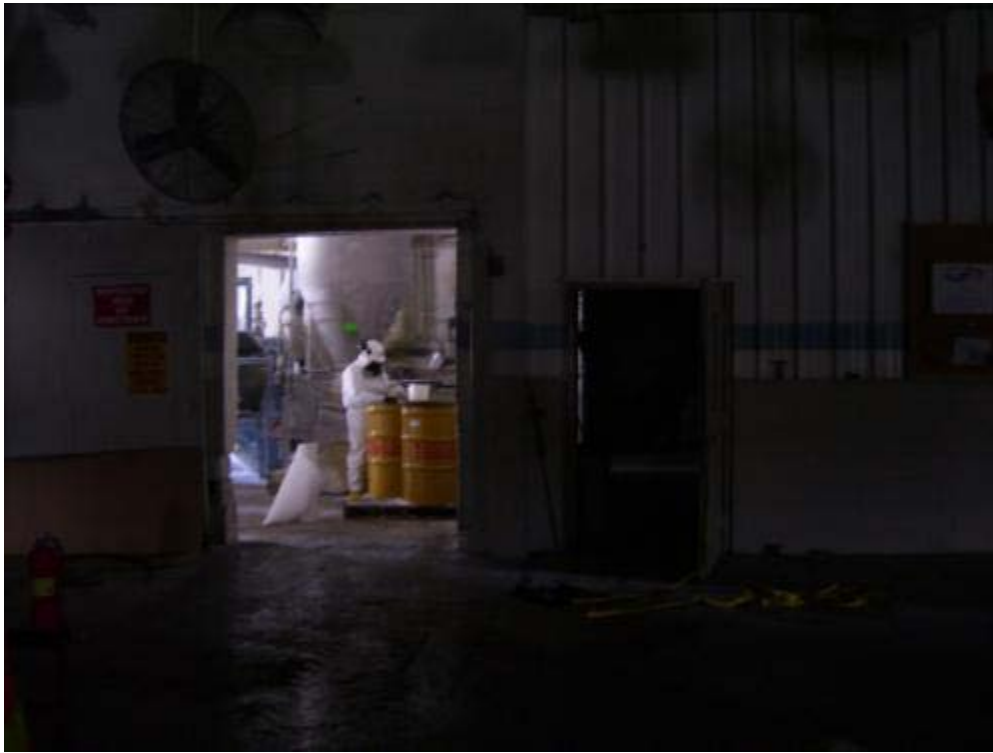
**Photograph No.:** 41

**Subject:** Manual transfer of liquid resin from tank T004 into an empty drum

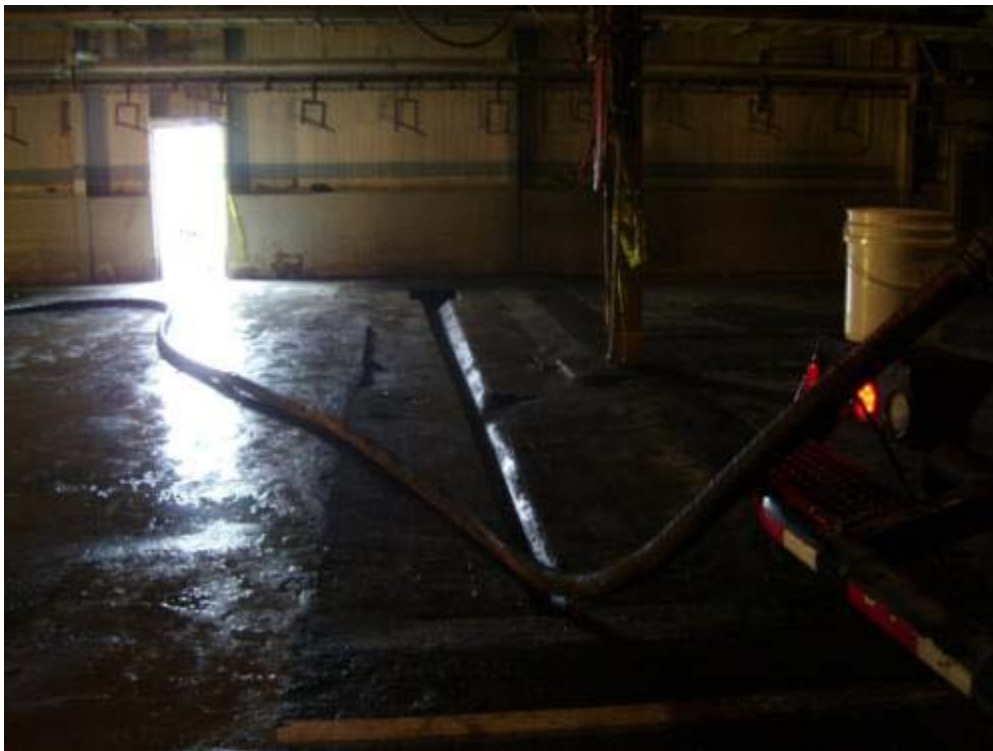
**Photograph No.:** 52

**Subject:** Subfloor pit P013 after pressure washing

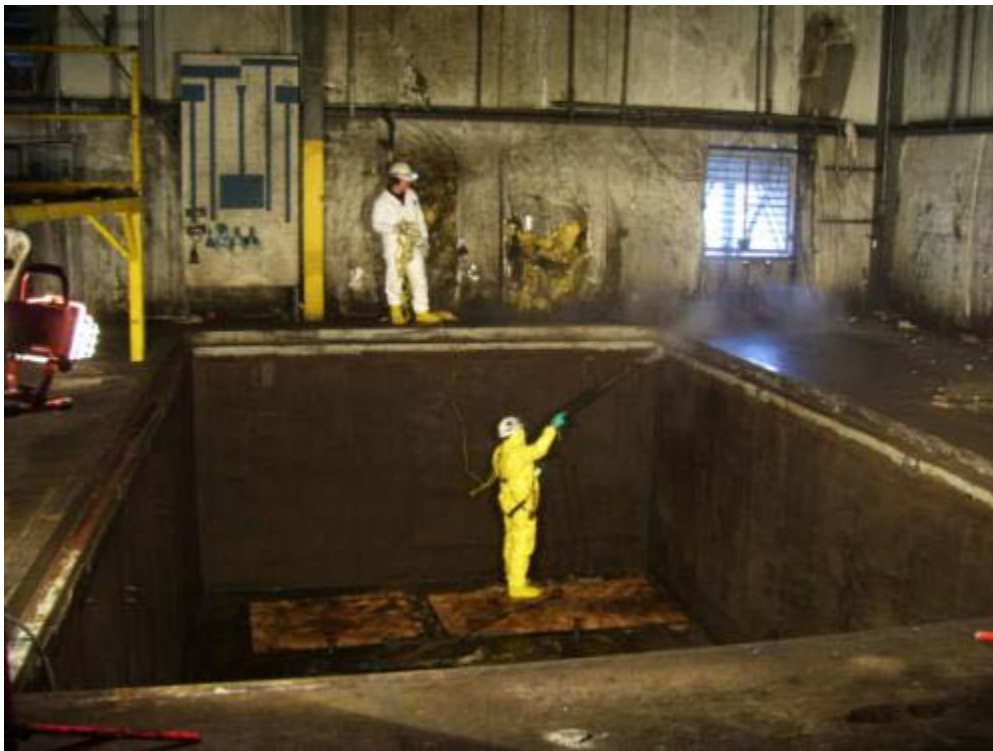
**Photograph No.:** 56

**Subject:** Pressure washing subfloor pit P001

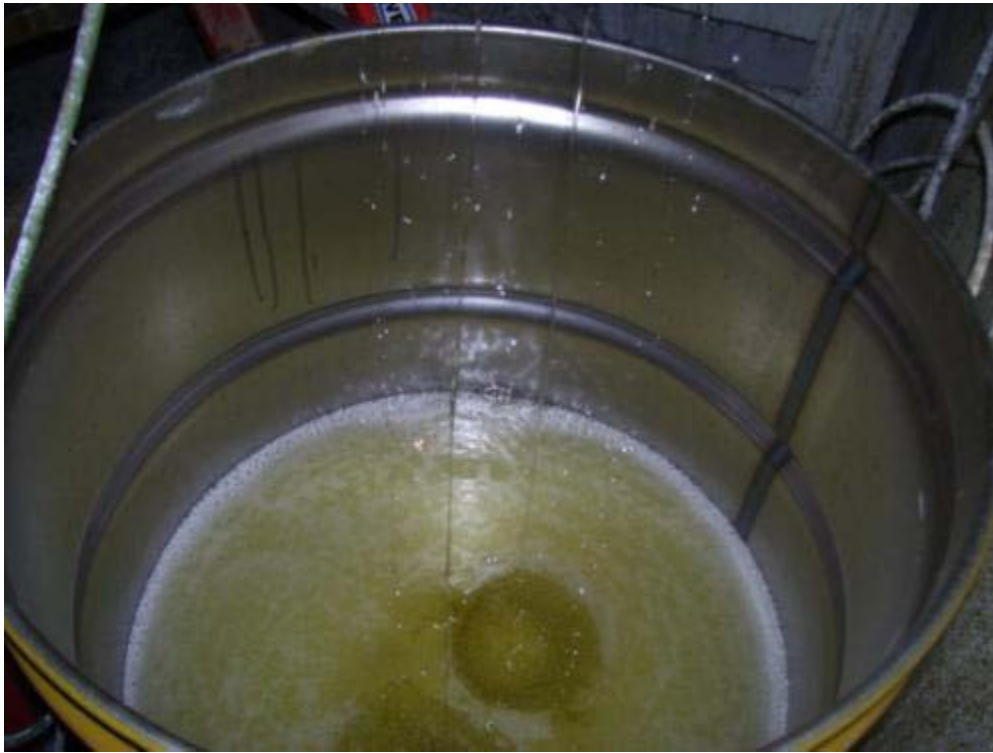
**Photograph No.:** 65

**Subject:** Liquid resin product drained from the T030 pipeline terminating in Room 18

The ERRS crew also drained liquid resin from three former product transfer pipelines between tanks T030, T031, T032, and the SMC mix room (Room 18). Valves were either opened or removed, depending on condition, at the terminations of the pipelines in Room 18 and at the outdoor resin tanks. The liquid contents of the pipeline from tank T030 were gravity-drained into two 85-gallon drums from a valve in the SMC mix room, and into two 55-gallon drums from a valve by the tank. The drums were marked and transported to the staging area.

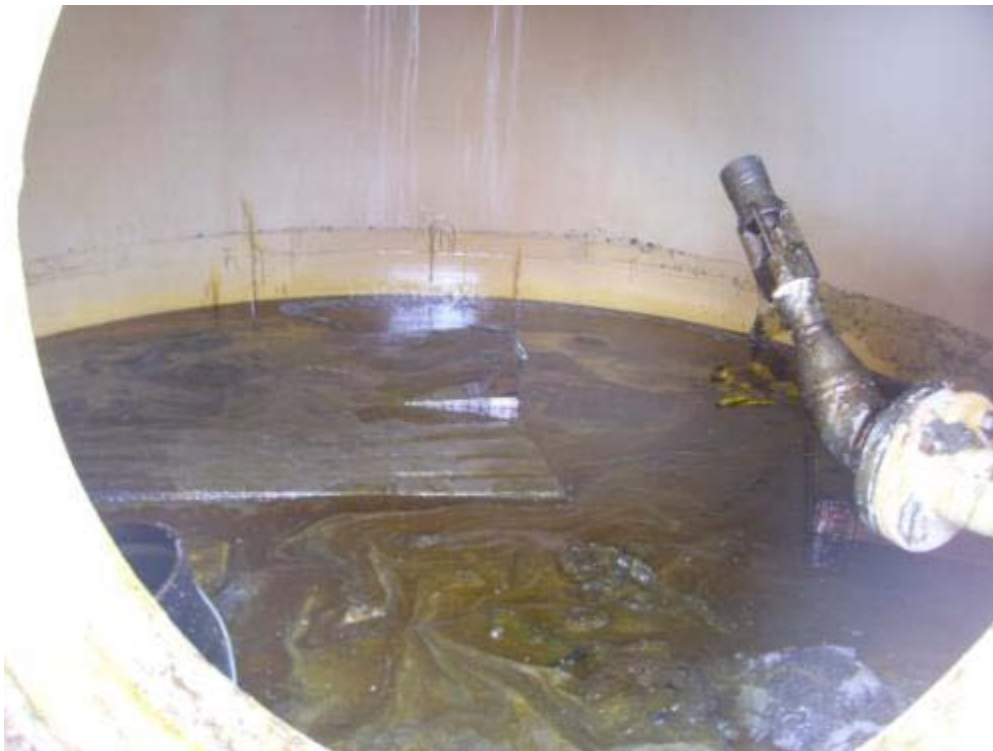
**Photograph No.:** 74

**Subject:** Interior of tank T031 after removal of liquid; 6 inches of residual mixed sand and resin
